Cleared for Take-Off GPS, GIS, and Removal of Airport Obstructions

Two months to deadline, underequipped, and underfinanced: The San Diego Airports Division and Department of Public Works GIS Division used a backpack GPS, GIS mapping, and simple instruments to identify trees obstructing the flight path at San Diego County Airport. Data collection and analysis targeted 22 trees for trimming or removal.

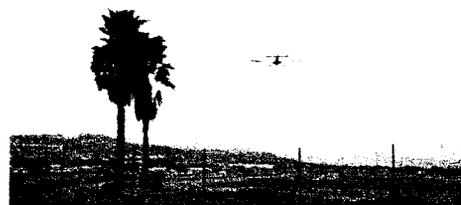
This airplane is on short final approach to runway 27L, crabbing into a crosswind from the southwest. The trees look close to its passage, yet they were not surveyed as potential obstructions.

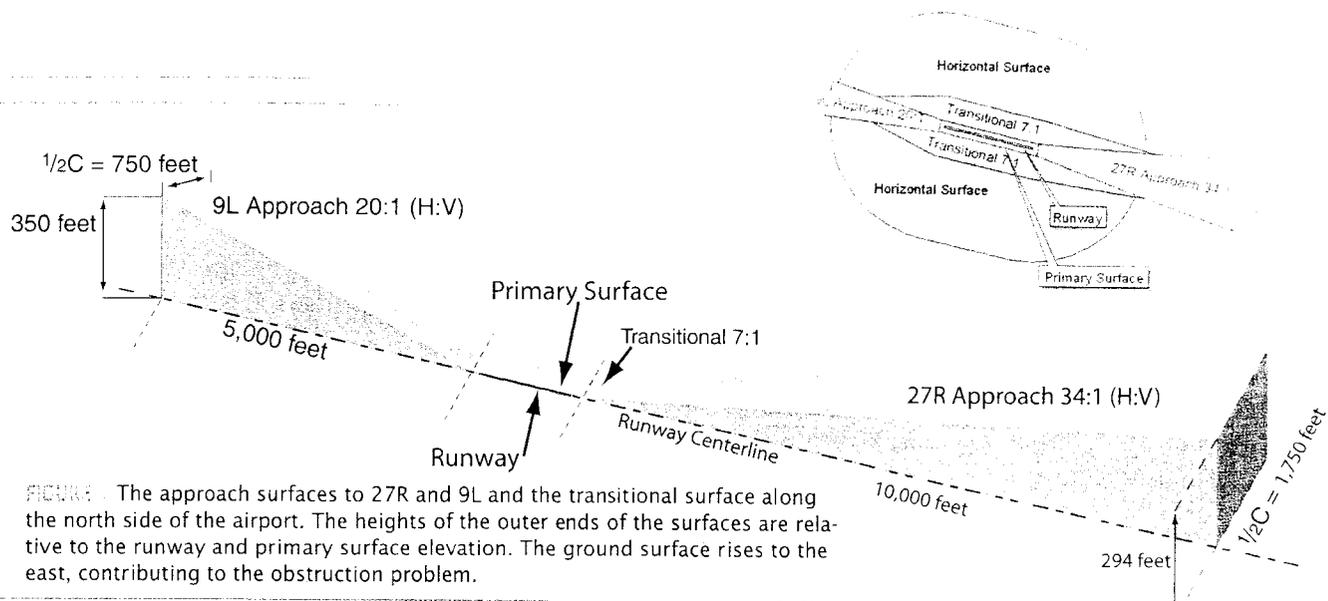
FIGURE 1 The approach surfaces to 27R and 9L and the transitional surface along the north side of the airport. The heights of the outer ends of the surfaces are relative to the runway and primary surface elevation. The ground surface rises to the east, contributing to the obstruction problem.
